CONNECTICUT RIVER BASIN  
BLOOMFIELD, CONNECTICUT

# **COLD SPRING RESERVOIR DAM CT 00495**

## **PHASE I INSPECTION REPORT NATIONAL DAM INSPECTION PROGRAM**

MAY 1981

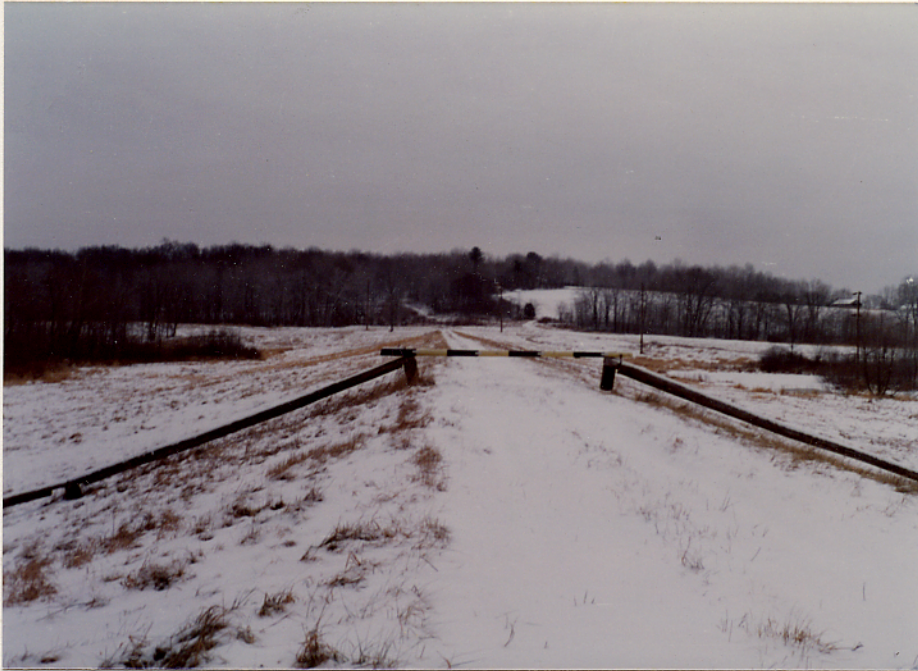
The dam is a grass covered, earthfill embankment with a gravel underdrain system on the downstream side. No sign of lateral movement or misalignment was observed as shown by Photos 1 and 2. Two low spots, each approximately 5 ft. by 8 ft. and 6" deep, were noted and are indicated on the general dam plan in Appendix B. Minor erosion down the embankment slopes was associated with these low spots, which is also shown on the general dam plan. The dam embankment was covered by a well developed growth of grass with minor vehicular rutting along the crest.

PHOTO 1 - View looking east along  
top of dam embankment.

It is recommended that the owner repair the wheel ruts, low spots, and minor erosion gullies on the crest and slopes of the dam and dike embankments within one year of this report. Other remedial measures contained in Section 7 should also be carried out within a period of one year.

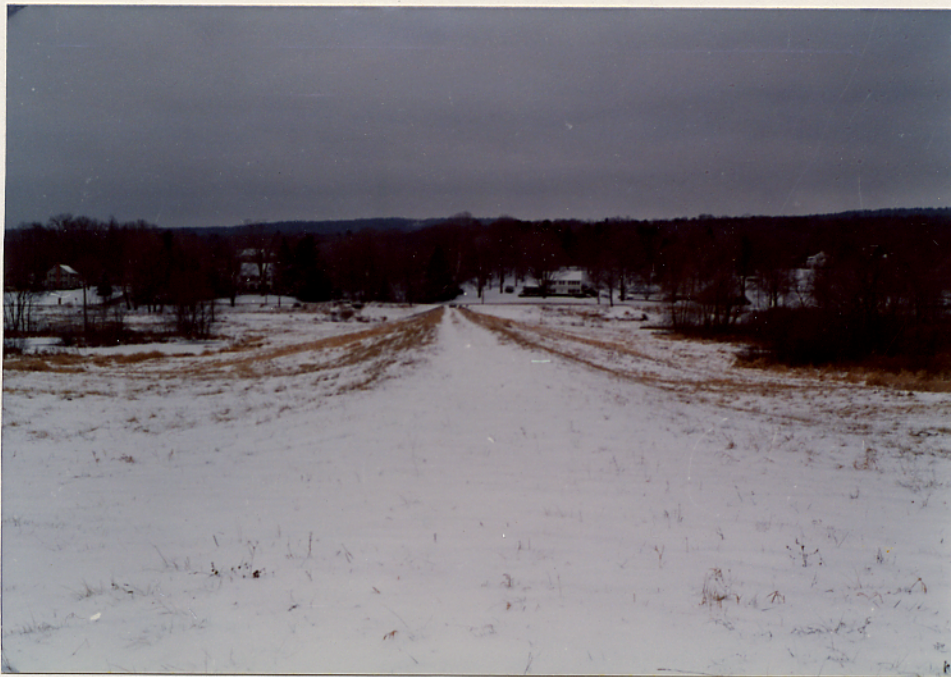
PHOTO 2 - View looking west along  
top of dam embankment

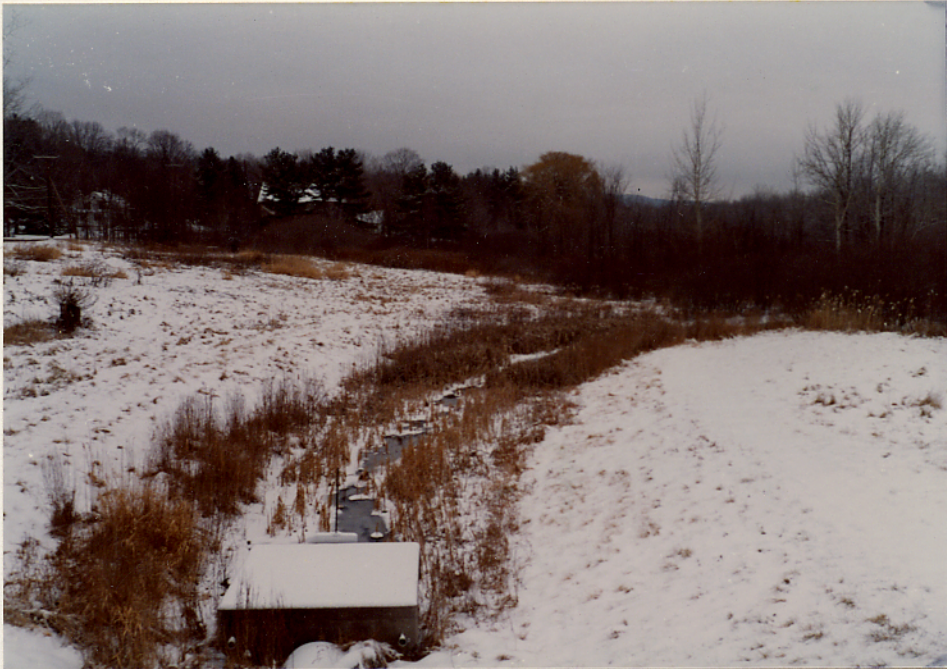
Consisting of a two stage reinforced concrete intake riser and a 36" reinforced concrete pipe, the principal spillway allows the normal flow of the brook and the impounded storm-water runoff to pass through the dam embankment. The concrete intake riser was in good condition with no sign of cracking or spalling. Located at the low level inlet was a sliding steel sluice gate which was open and presently inoperable. As shown in Photo 4, the gate stem was bent and the gate handle was missing from the sluice gate works. The upstream channel was clean of debris with some minor weed growth along the edges (Photo 3).

PHOTO 3 - Upstream Channel.

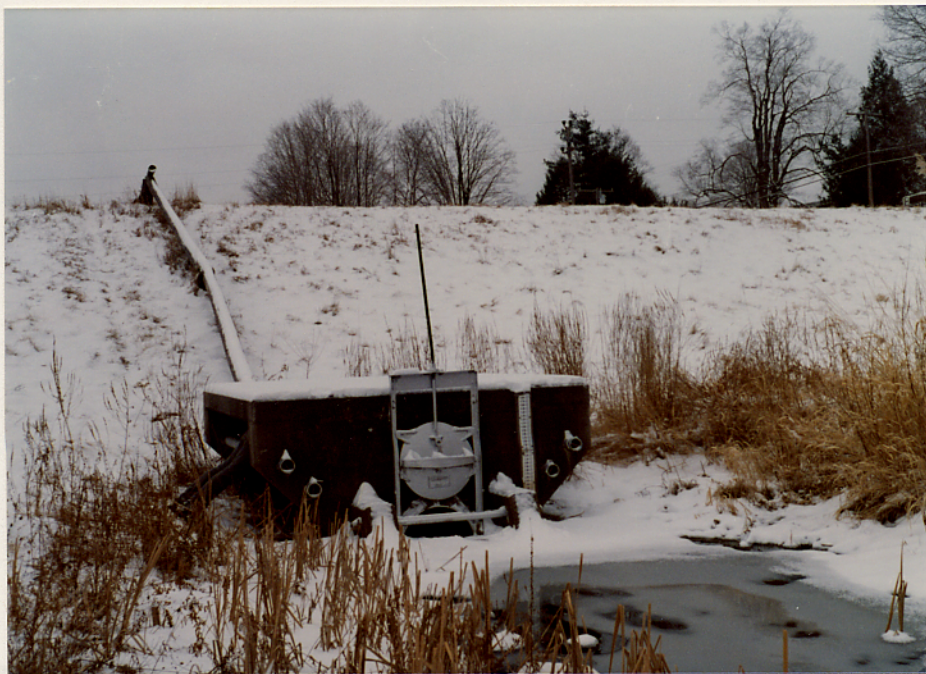
PHOTO 4 - Intake Riser - Slide Gate open. Gate stem bent and gate handle missing.

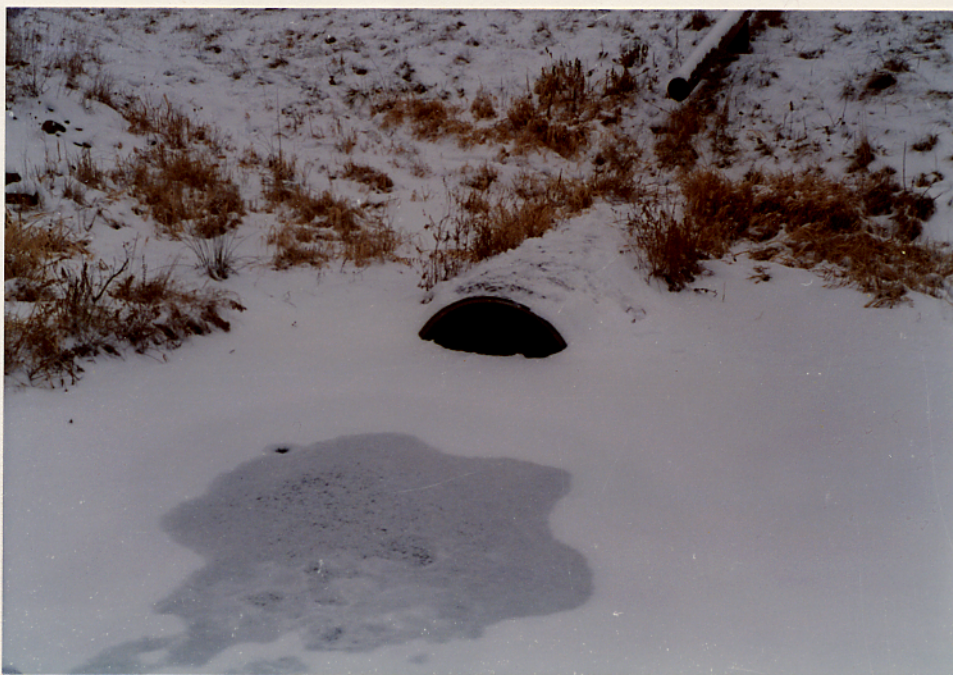
Minor exterior spalling of concrete was noted at the outlet end of the 36" reinforced concrete pipe. The pipe was over half full of water due to the flat downstream profile, preventing full interior inspection (See Photo 5). The rip-rapped area beyond the outlet pipe was clean and appeared stable.

PHOTO 5 - Principal Spillway  
Outlet Pipe

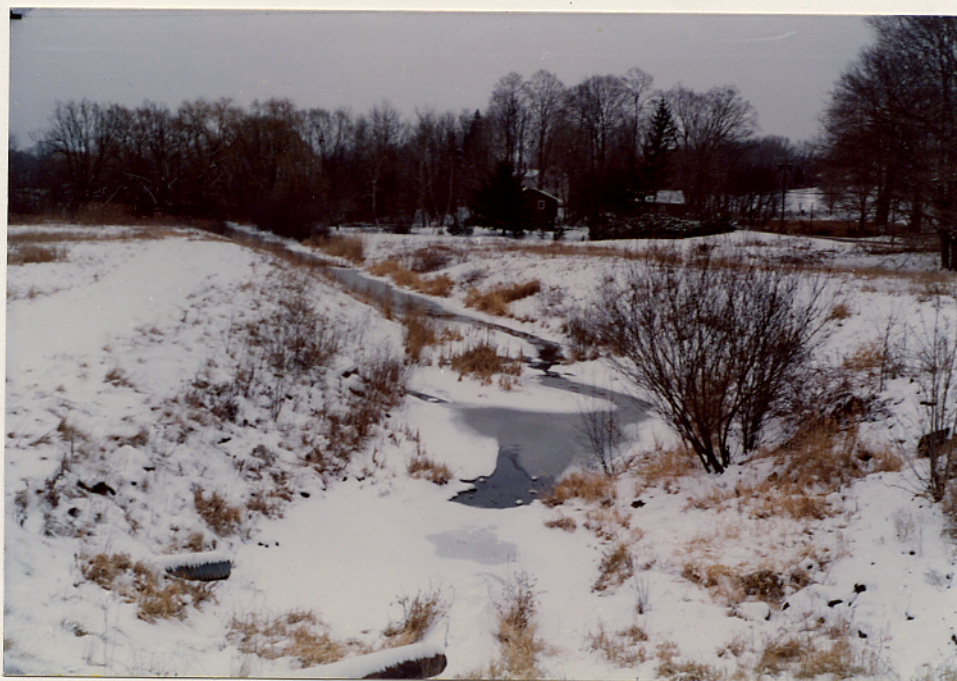
PHOTO 6 - Downstream Channel. Note  
minor channel obstructions.

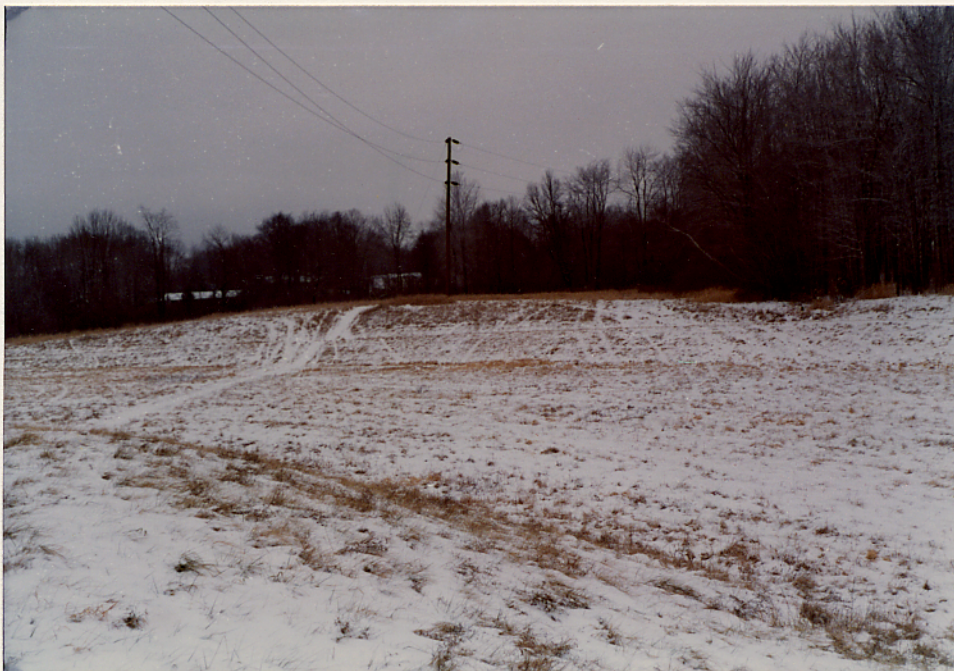
Located at the east end of the dam, the grass lined spillway was generally in good condition. The grass lining appeared stable with evidence of moderate vehicular trespassing

PHOTO 7 - View looking at inlet end  
of emergency spillway.  
Note vehicle use.

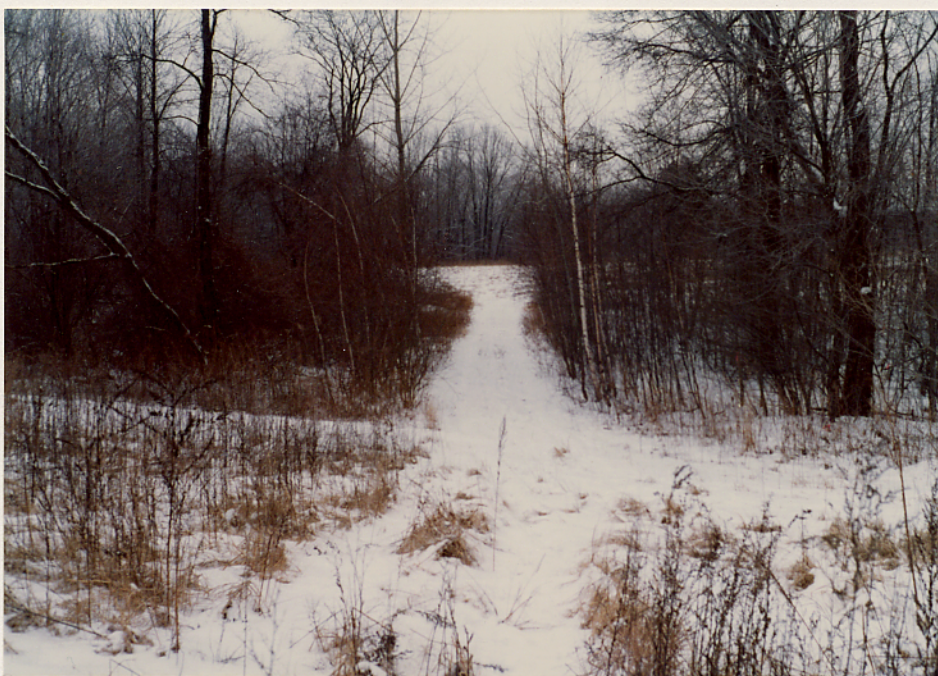
The dike is a low grass covered earthfill embankment located at the northeast corner of the reservoir, and appears to be used as a farm road (See sheet 2, Location Plan, for dike location). Severe vehicular rutting and very minor slope erosion was observed respectively, along the crest and slopes of the dike embankment. The upstream and downstream slopes and toes were moderately covered with brush and small trees as shown in Photo 8.

PHOTO 8 - View looking south along  
minor dike.
